RICS Home Surveys
Survey level two:
HomeBuyer report
- Survey & Valuation

Date of inspection

29th August 2017

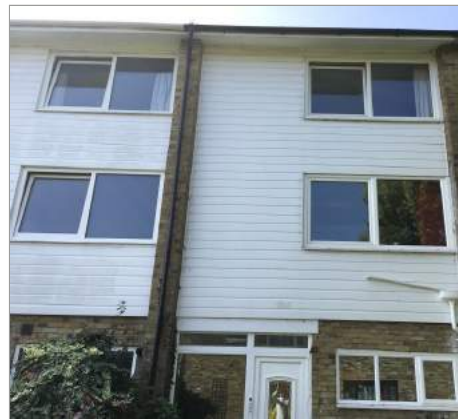
To the rear the central pier requires making good and to the front there is evidence of damp staining from overflow pipes. It should be checked that this issue has been fixed.

Photo - 4 Staining to front pier

The rear pier should be repaired to prevent material loosening further and the structure breaking down and being a safety risk. The front pier has leak staining from the overflow. The overflow should be checked to ensure the issue has been addressed as long term leaking could lead to damp penetration.

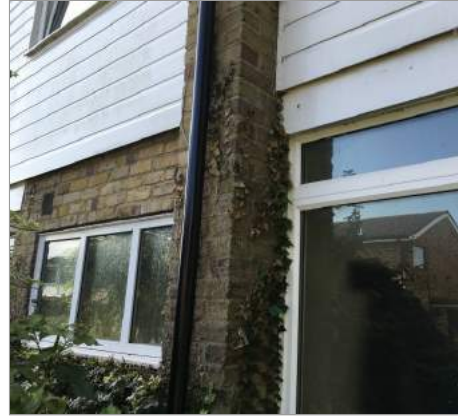
Photo - 6 Remove ivy

Self-clinging climbers such as Boston ivy and Virginia creeper (*Parthenocissus* sp.) do not usually cause damage to wall surfaces, but common or English ivy (*Hedera helix* sp.) supports itself by aerial roots and where these penetrate cracks or joints they may cause structural damage. Sound masonry is unaffected. Its dense cover can hide defects in the fabric of the building and hinder maintenance work. Ivy may also provide access for intruders and harbour pests such as mice. Where brickwork is sound, the main problem is to keep growth away from gutters and paint work. It has been suggested that vegetation attached to walls could lead to dampness resulting from slower drying conditions following rain. This may be plausible on a south-west facing wall where the rain is driven by prevailing winds. However, other sources suggest that such plants will have a slight drying effect on mortar and will also provide some degree of insulation in winter, particularly evergreen ivies covering exposed north and east-facing walls. Large climbers can pose a risk to buildings. Such problems are most likely with older property, those with shallow foundations and those built on clay soils.

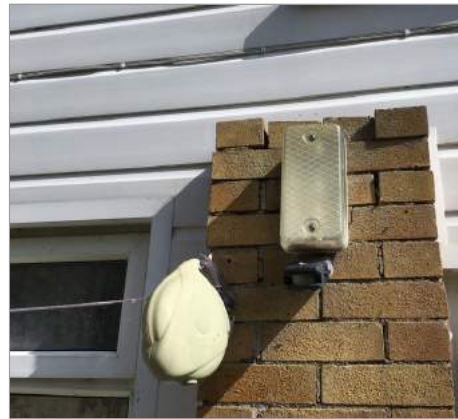
Photo - 8 Repoint rear pier

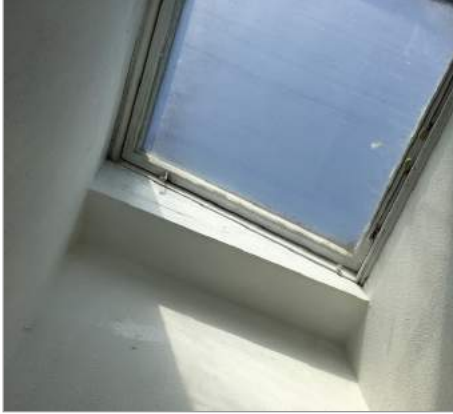
Photo - 9 Maintain/replace roof light

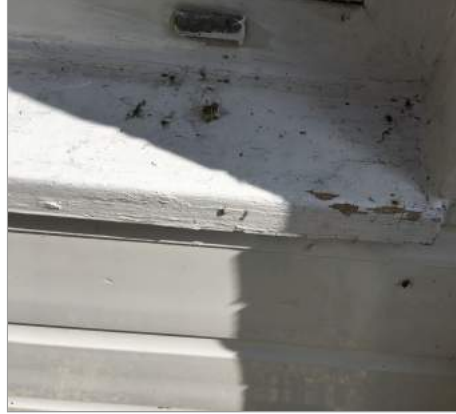
The windows were UPVC double glazed and appeared to be in fair condition. The cills were UPVC other than the ground floor rear bedroom which was timber and in need of maintenance.

Photo - 10 Maintain timber frame

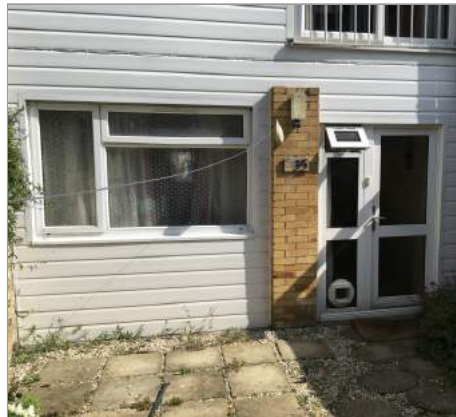
Photo - 12 Middle side pane to be confirmed as safety glazing. Back door key to be located and door tested to see if it opens

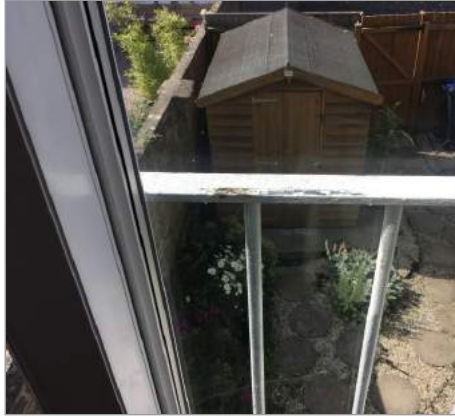
At first floor level there was a Juliet balcony, the metal guarding requires maintenance and the height and gaps between the vertical members were not compliant with current standards. Current standards require a height of 1100mm and gaps which will not allow a 100mm sphere to pass through them. Whereas the gaps were in excess of 100mm and the height just under 1000mm. It is likely that this detail was built with the property under different standards as such it is only recommended that the balcony guarding be changed.

Photo - 14 Maintenance required

The metal guarding to the Juliet balcony if not replaced should be treated to prevent further corrosion.

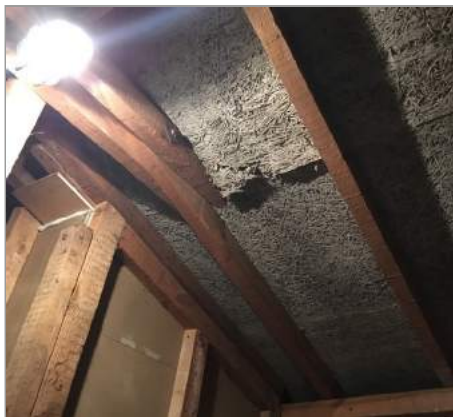
The roof structure appears to be an early form of truss and supports a felt which shows signs of damage in places. It is not known whether the felt is asbestos based as such further investigation is required. In the roof space there is some boarding to joists and a very thin amount of insulation visible in other areas. 2

Photo - 20 Repair felt and find out what the material is before doing so.

The felt is damaged in the roof space which could lead to damp penetration. The felt could be asbestos based which could lead to health risks.

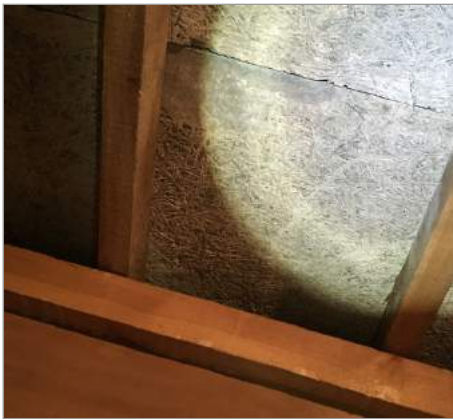
Photo - 24 Felt could be asbestos based?

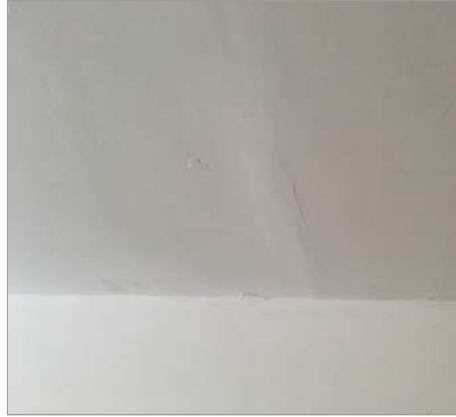
Other ceilings appear to be plaster skim with areas of making good required and poor patch up works in the past having been done. In the front second floor bedroom stickers are also stuck to the ceiling which when removed could cause damage.

Photo - 27 Poor plaster skim patch up

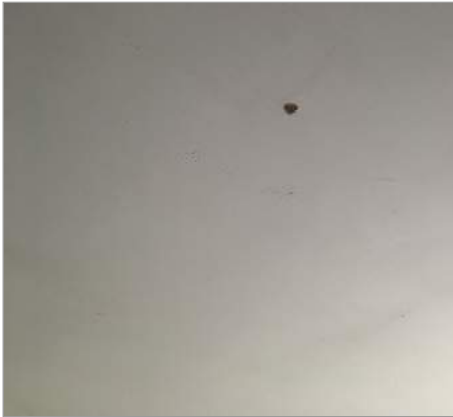
Photo - 28 Mechanical damage

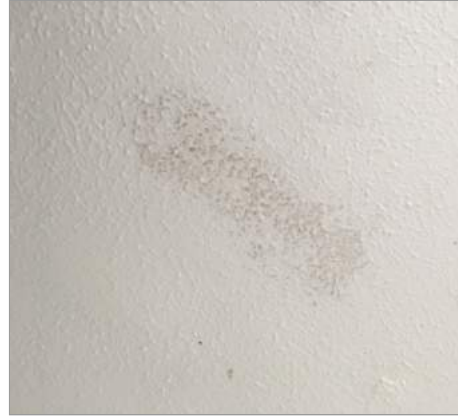
Photo - 31 Dirt/mould

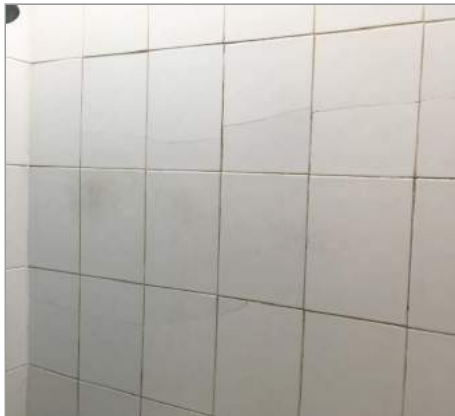
Photo - 32 Cracked tiles

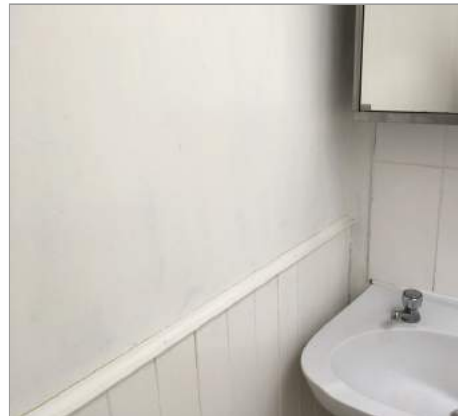
Photo - 33 Timber panelling is a fire risk

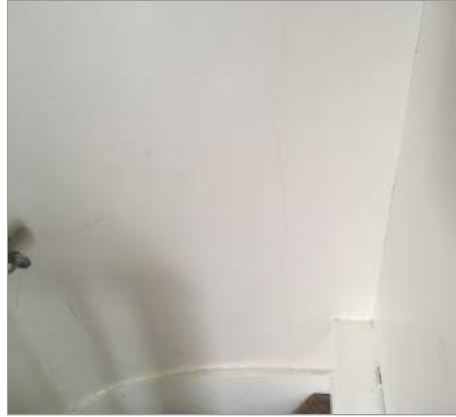
The walls are a mixture of plaster skim, tiles, wall paper and timber panels in the bathroom. There are areas of making good required and what appears to be poor patching up. At second floor level on the stair is an almost vertical hairline crack running from the timber rail to the ceiling. There is a shorter crack at ground floor from the stair soffit down part of the wall. It should be ensured that the cracks do not extend through to the structure of the walls. They are believed to be vibration but should still be assessed by a structural engineer.

Photo - 35 Crack on second floor stair

The cracking described for internal walls should be investigated further to confirm it is not structural.

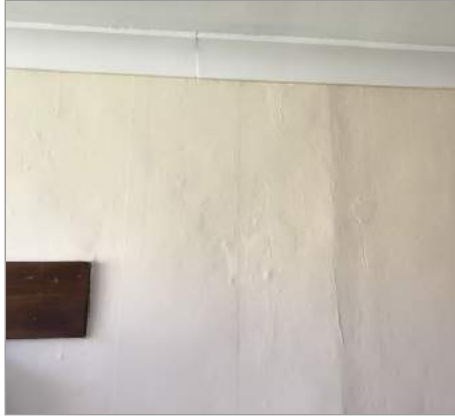
Photo - 38 Crack to ground floor wall

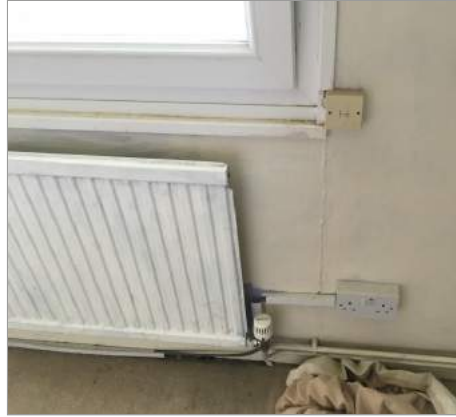
To the walls internally to the UPVC cladding, there appears to be expansion and contraction cracks between board joints and where radiators have been fixed.

Photo - 39 Expansion contraction cracking

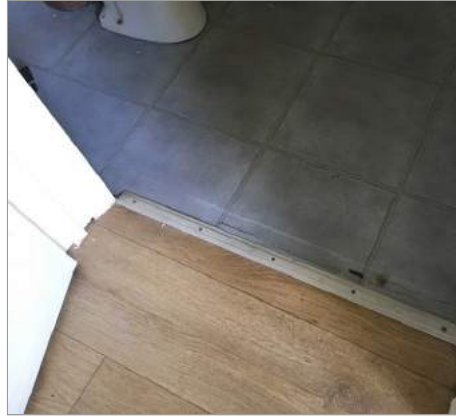
Photo - 42 Damage to cloakroom floor

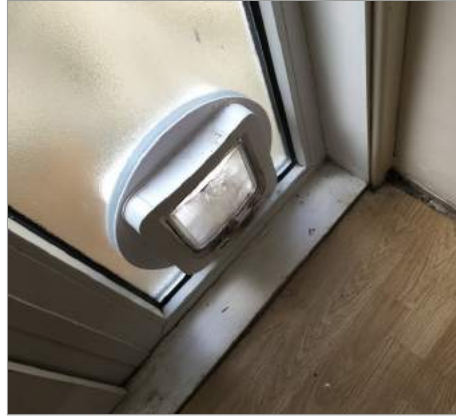
Photo - 46 Poor detailing

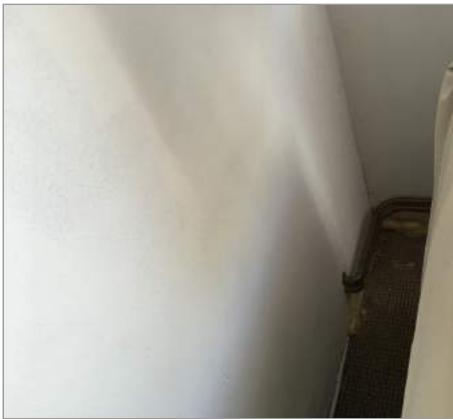
The rear ground floor bedroom has poor detailing at its bottom with foam filling of gaps.

Photo - 47 Foam at bottom of wall

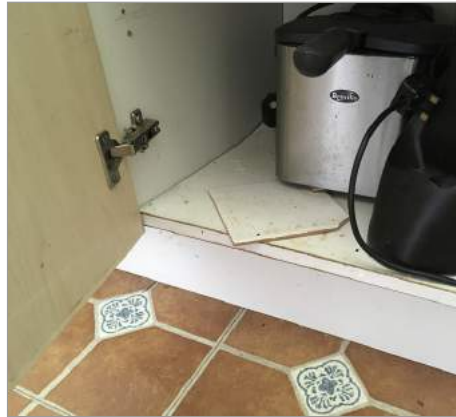
The kitchen appears to be ok but in need of repair works and sealant renewal at the edge of the worktop where it meets the wall. The floor of the under sink cupboard is broken. 2

Photo - 51 Damage to cupboard

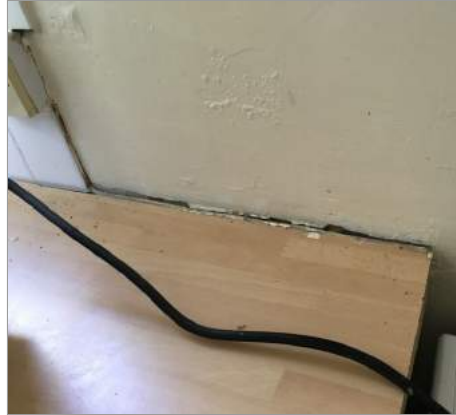
Photo - 53 Sealant required

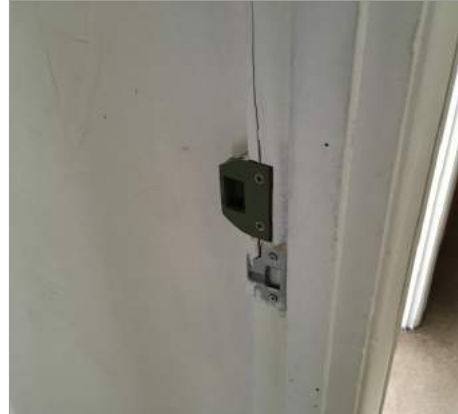
Photo - 55 Split to door frame lining

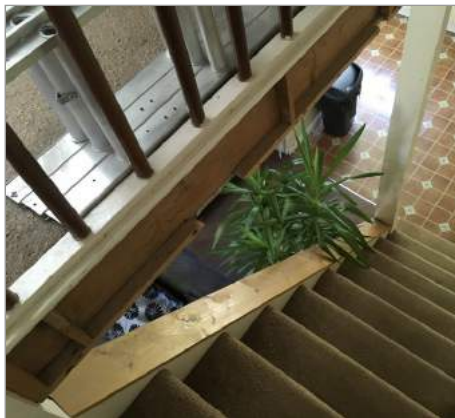
The guarding to the stair at first floor level is missing and as such is a fall risk, the gaps between guarding members at second floor level is in excess of current standards and the edge of the floor at second floor on the stair is exposed.

Photo - 56 No guarding

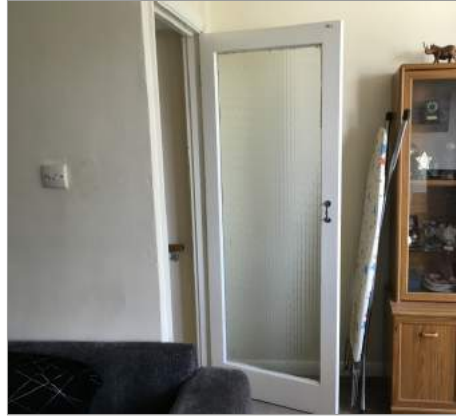
The property has glazed doors on the stair which are Georgian wired which were historically acceptable as fire doors but not currently. The glazing above the doors would need to be fire resisting and the doors to all rooms changed accordingly as they were not fire doors. The strips to the old Georgian wired doors are old and defective.

Photo - 59 Georgian wired door should be safety glazing

The Georgian wired glazing is located in critical locations and as such should be safety glazed to reduce the risk of serious injury on breakage.

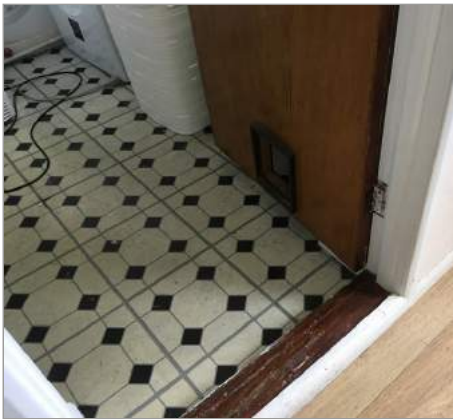
Photo - 60 Cat flap breaches door integrity. It should not be cited in a fire door

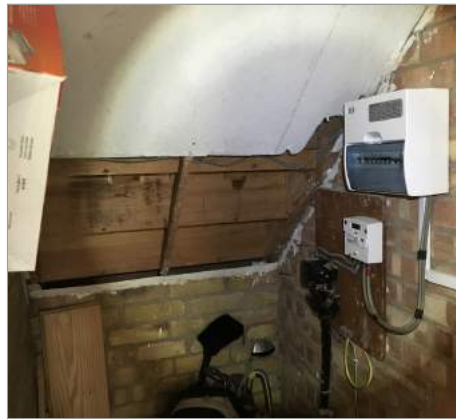
The boarding in the ground floor store to the under side of the stair is damaged and may be asbestos based. This should have 30 minutes fire resistance.

Photo - 61 No fire protection to stair under side

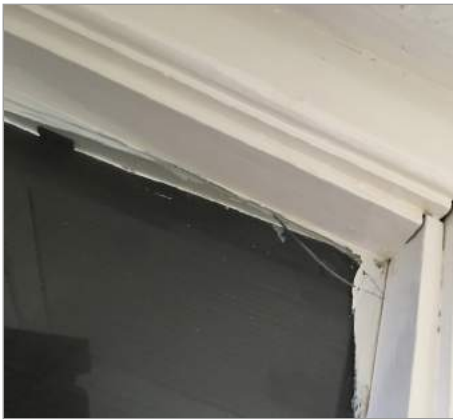
Photo - 64 Crack to door glazing to bedroom. It should be fire rated if on a protected stair

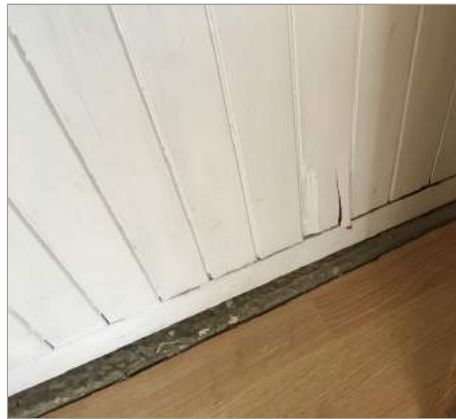
Photo - 65 Damage to under stair cupboard door

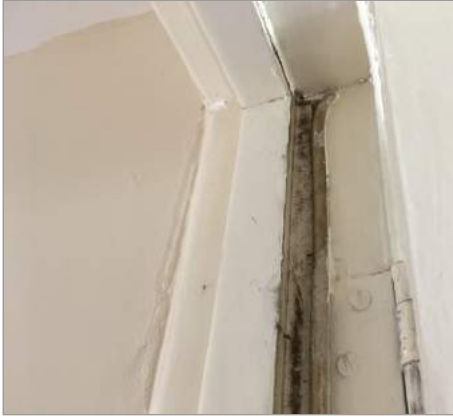
Photo - 66 Defective fire door strips

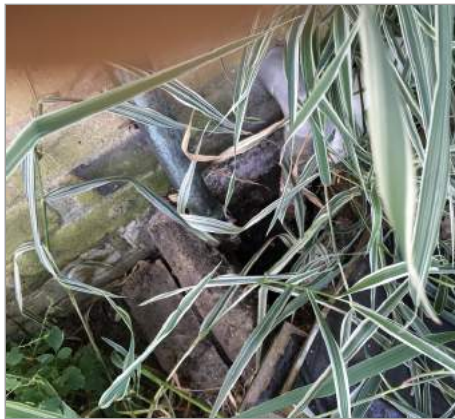
Photo - 83 Front gully

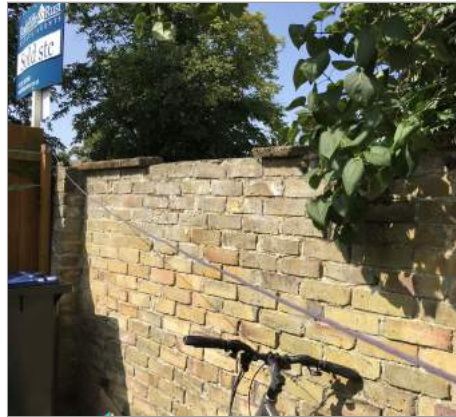
Photo - 92 Requires maintenance

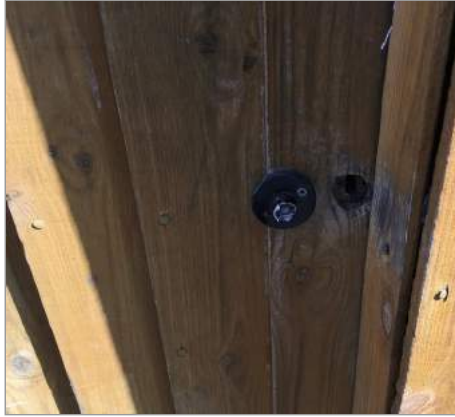
Photo - 93 Requires repair
