RICS Home Surveys
Survey level two:
HomeBuyer report
- Survey & Valuation

Date of inspection

29th August 2017

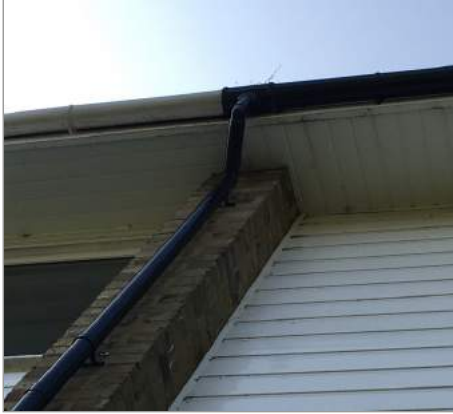
The rainwater goods are UPVC and terminate below ground. They appear to be in fair condition however, the vegetation requires removal.

Photo - 2 Remove vegetation from guttering

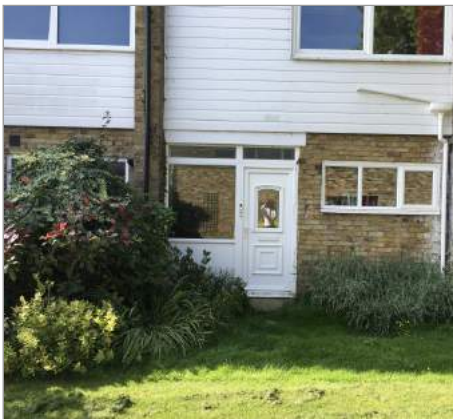
Photo - 3

To the rear the central pier requires making good and to the front there is evidence of damp staining from overflow pipes. It should be checked that this issue has been fixed.

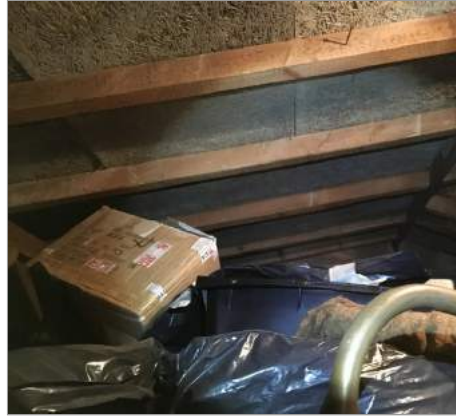
Photo - 23 Water tank

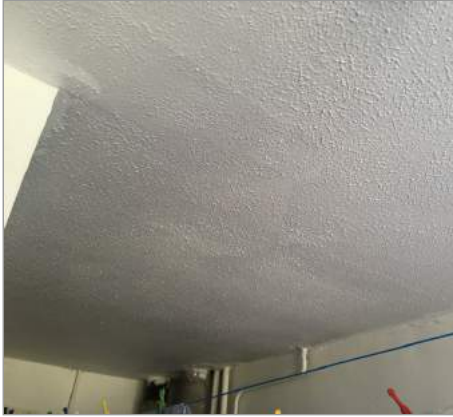
A textured decorative coating covers the ceilings in the utility room, cloakroom, living room and second floor. This may contain small amounts of asbestos fibres and if disturbed, it could be a safety hazard (see section J3 Risks). If the ceiling needs decorating or repairing, you will have to use a contractor experienced in this type of work or an asbestos specialist.

Photo - 26 Could contain asbestos

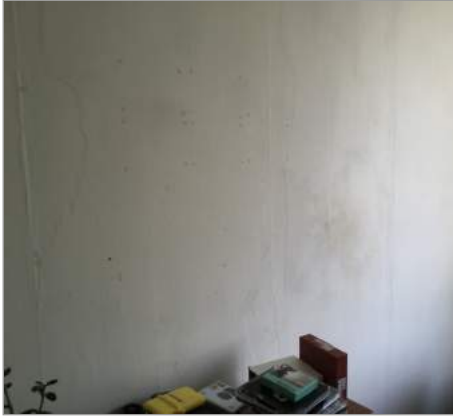
The walls are a mixture of plaster skim, tiles, wall paper and timber panels in the bathroom. There are areas of making good required and what appears to be poor patching up. At second floor level on the stair is an almost vertical hairline crack running from the timber rail to the ceiling. There is a shorter crack at ground floor from the stair soffit down part of the wall. It should be ensured that the cracks do not extend through to the structure of the walls. They are believed to be vibration but should still be assessed by a structural engineer.

Photo - 34 Walls require making good, cleaning and redecoration throughout.

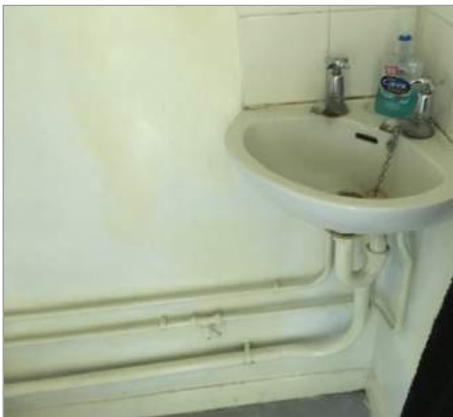
Photo - 71

There is no mechanical extraction to outside air in the utility room, kitchen, cloakroom or bathroom. All have openable windows except the cloakroom and bathroom, as the location means the roof light would probably not be used. The cloakroom should under current standards have extraction at the very least. Fitting extraction to all aforementioned areas is recommended as this helps remove foul smelling and warm moist air which could condense on cooler services leading to mould and internal finish damage from damp.

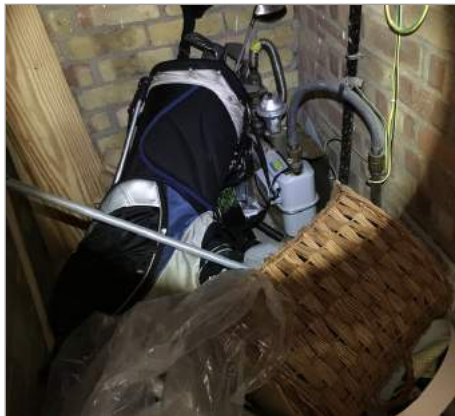
Photo - 75

The stop cock is located in the utility room, the Incoming water supply pipe may be of copper, Alkathene (plastic) or lead. Lead pipes are vulnerable to leakage and also considered as unhealthy. It is not always possible to see the incoming water main and therefore identify the type. Bringing a new supply into the house could be expensive depending where the main supply is. If this was necessary then there are certain regulations that apply.

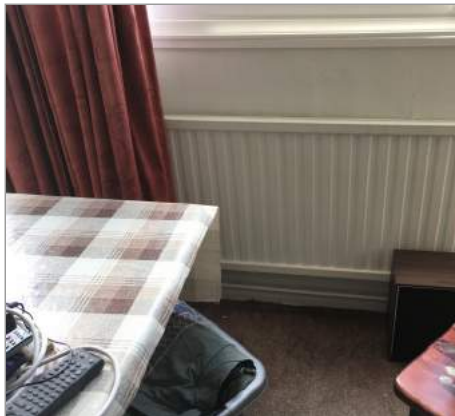
Photo - 77

All heating system components should be inspected and tested by an engineer registered under a competent person scheme listed on the governments competent person scheme website. In the absence of electrical certification, the surveyor must give designation 3 for this item.

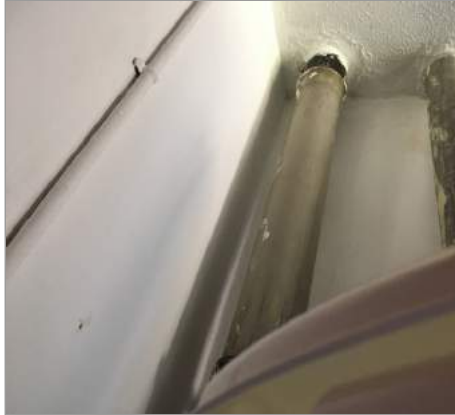
Photo - 81 Services should be boxed in in fire rated construction or fitted with fire collar to soil and vent pipe

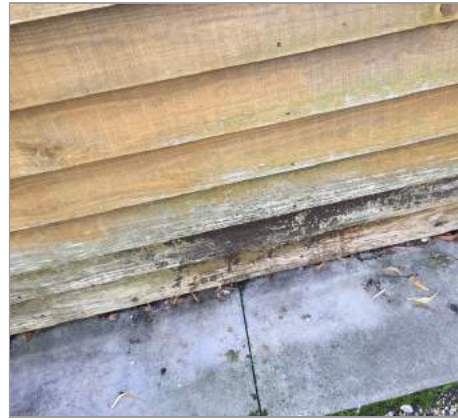
Photo - 88

The timber shed was locked and could not be opened due to the key not being provided. The condition of the shed is fair but further investigation is required.

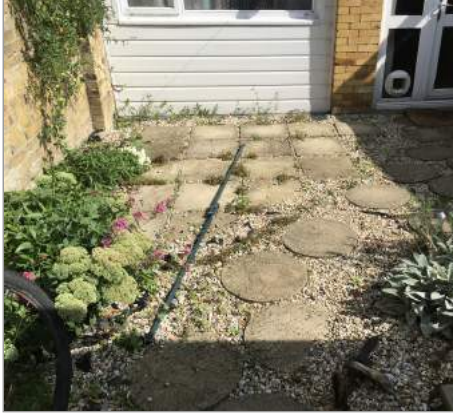
Photo - 89

The fences appear ok however, maintenance is required to the wall. The gate external joinery is missing and damaged with the lock being up side down.
